# SERVICE LETTER 1989-2C

**SUBJECT:** Normal Criteria for Static Blade Shake and Twist of McCauley Propellers

**MODELS AFFECTED:** All Variable Pitch Propellers

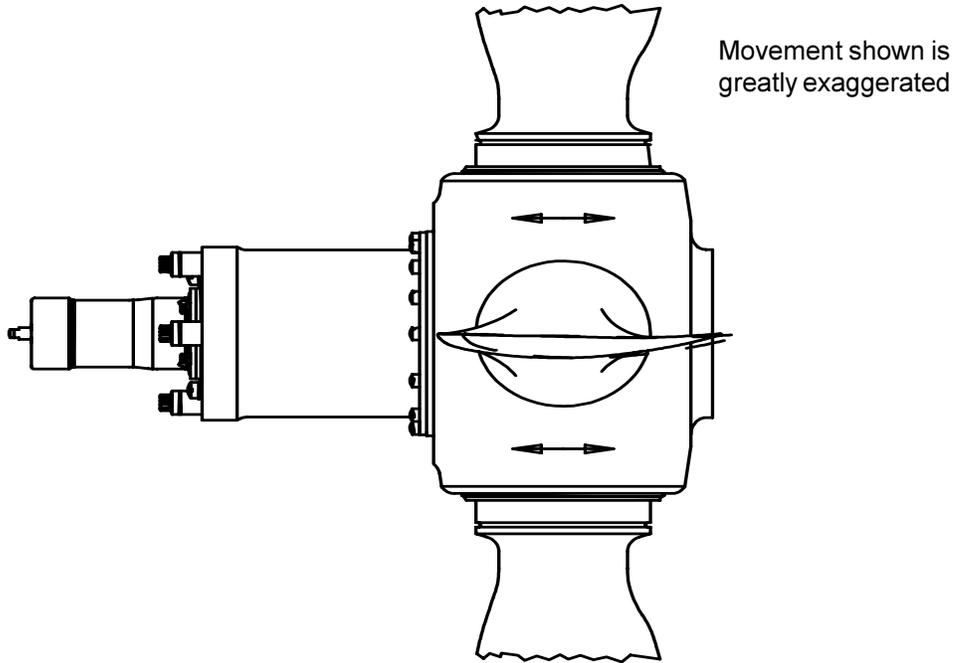
Figure 1 - Blade Shake

Blade shake is defined as the tendency for the propeller blades to wobble slightly when the tip is physically moved by hand (lead edge to trail edge; see Figure 1). This tendency is a natural result of the fabrication of parts within the McCauley retention system. While accumulation of tolerances is measured in thousandths of an inch, it must be remembered that both the parts causing blade shake, and the pivot point about which the blade rotates, are near the blade root. As a result, very small differences at the blade root will be magnified many times when measured at the tip. Total maximum allowable movement up to 1/8 or .125 inch (3.13mm) is considered normal. C1100 series propellers may have a maximum movement of 3/16 or .1875 inch (4.7mm).

Normal blade shake (less than maximum allowable movement) is no cause for concern, as it disappears during propeller rotation due to the high centrifugal forces acting on the blades (20,000 - 45,000 lbs.).

If, however, blade shake exceeds maximum movement allowable, it should be reduced, *when convenient*, by inserting shims in the blade assembly by an FAA-approved propeller repairman. In many cases, adjustment can be performed with the propellers still installed on the aircraft. Refer to the appropriate McCauley Service Manual for instructions on installing shims.

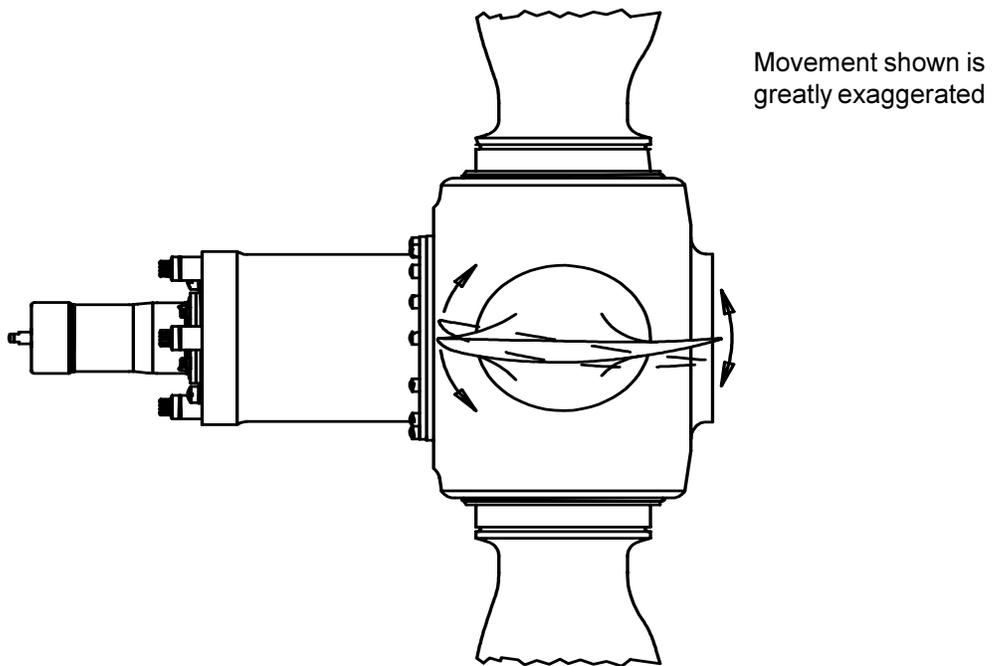
Figure 2 - Blade Twist

A. The first type is "rotational play" and can be defined as the sum total of rotational movement a propeller blade allows when moved by hand around its axis of rotation (see Figure 2). This movement is, to a limited degree, considered normal and should not be cause for concern. Please note that, while a specific rotational movement limit is no longer given, all blades in a propeller should have about the same amount of "rotational play". If the *difference* in rotational play between two blades is beyond 1.0 degree, uneven internal wear and/or damage is the possible cause.

(For example, rotational movement of No. 1 blade measures 1.2 degrees, and No. 2 blade measures 2.3 degrees. This would be considered excessive since their difference is beyond 1.0 degree.) The cause of the excessive difference should be determined by an FAA approved propeller repairman or international equivalent at the next opportunity.
